Garmin nuviCam LMTHD Motherboard Replacement

Written By: Riki Wippel

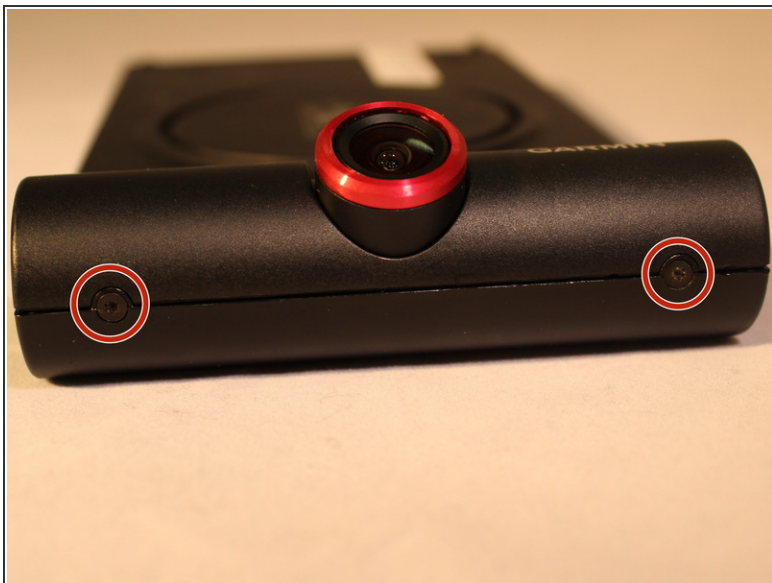
Step 1 — Screen

- Remove the four 6.9 mm black screws using the T6 screw bit.

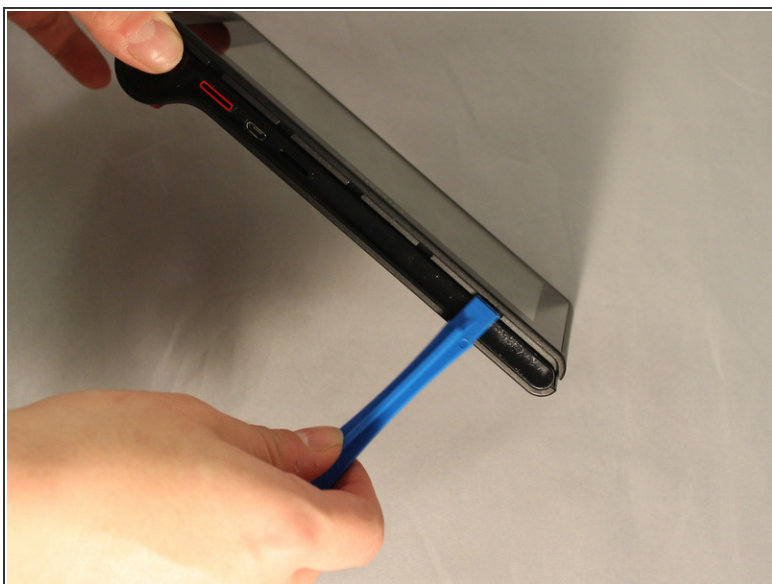
Step 2

- Pry the device open using a plastic opening tool.
- We suggest starting from the dash camera side for easier opening
- ⓘ You may have to use a little force, the screen is hard to remove.

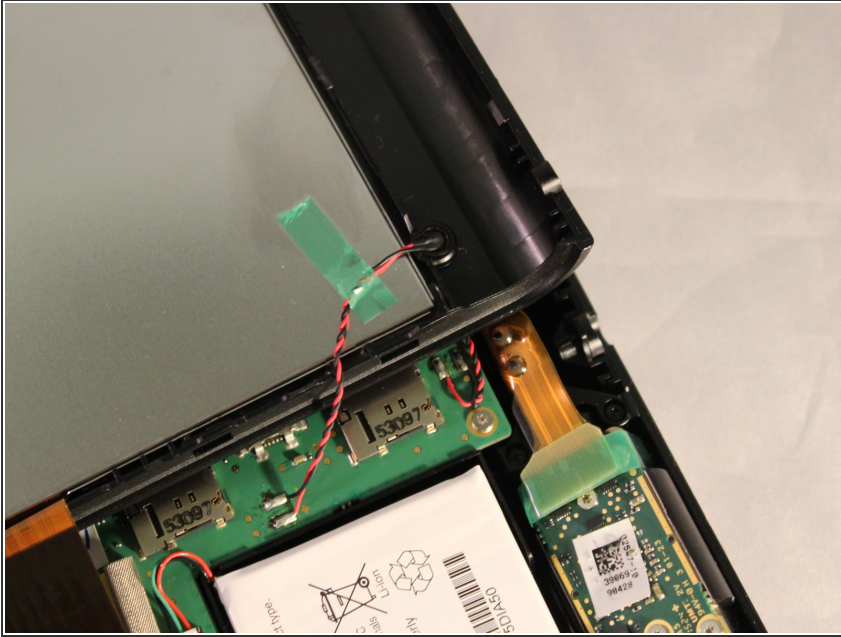
Step 3

- Disconnect the black and red wire from the screen.

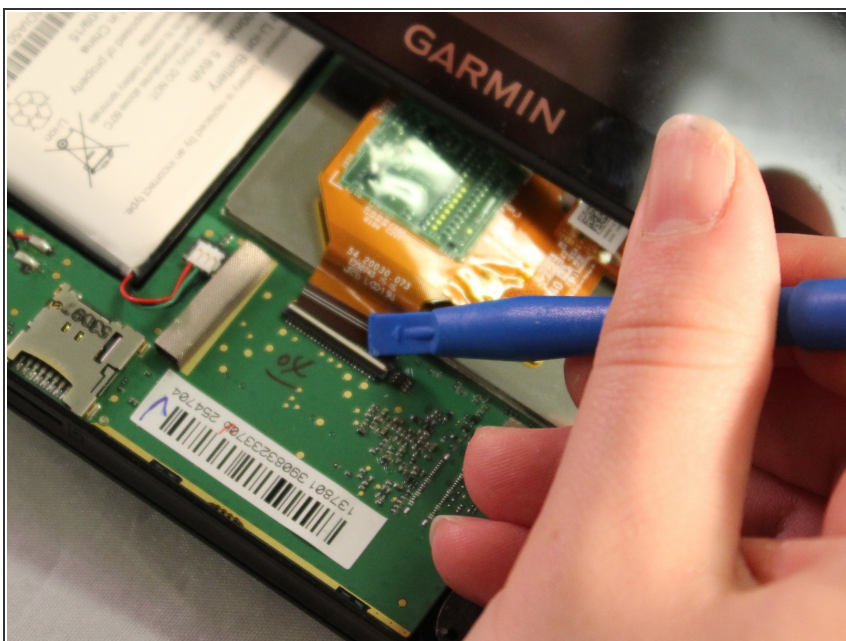
Step 8

- Disconnect the orange cable strip connected to the screen using a plastic opening tool, lift white teeth up and slide strip out.
